**Inspection Report**

**Mine Name:** Pebble Puppy 1 & 2  
**Operator Name:** Bluebell Oil Company

**Permit number:** S0470050  
**Inspection Date:** April 19, 2007  
**Time:** 3:15-3:45 PM

**S0470050, Pebble Puppy 1 & 2, Bluebell Oil Company**

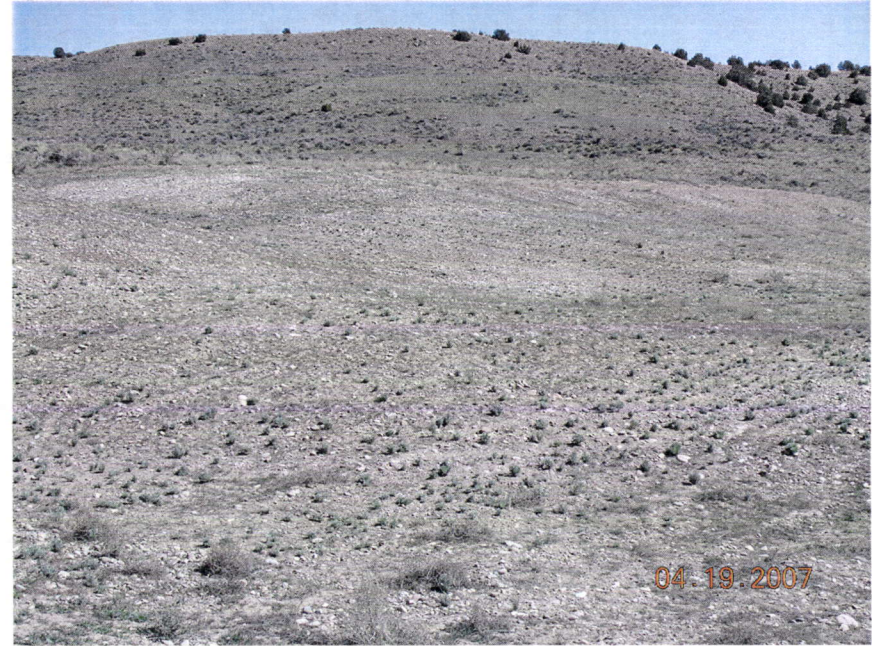
This area (the area on the south) was regraded and seeded by the BLM in 2004. (The area on the north was *apparently* not seeded.) We found numerous Indian ricegrass and some needle-and-thread and fourwing saltbush plants. More than anything else, we found many sagebrush seedlings in rows as if they had been drill seeded. There was little cheatgrass in this area although there was a lot of cheatgrass in adjacent undisturbed areas and in the reclaimed area to the north.

**Photo 2. Note the numerous sagebrush seedlings, mostly in rows.**

This portion of the site has enough vegetation that it could probably be released if the operator would request release. Other aspects of reclamation, such as grading, removal of facilities, and erosion control, are all adequate. The portion of the reclaimed area north of the drainage probably does not have adequate vegetation for release, but it would be necessary to take quantitative measurements to be sure.
